**International Conference on
Engineering and Ecohydrology
for Fish Passage
Madison, WI**

Design and Management of a Multifaceted Fish Passage Improvement Project – The Mirabel Case Study

Jon Mann, PE

June 10, 2014

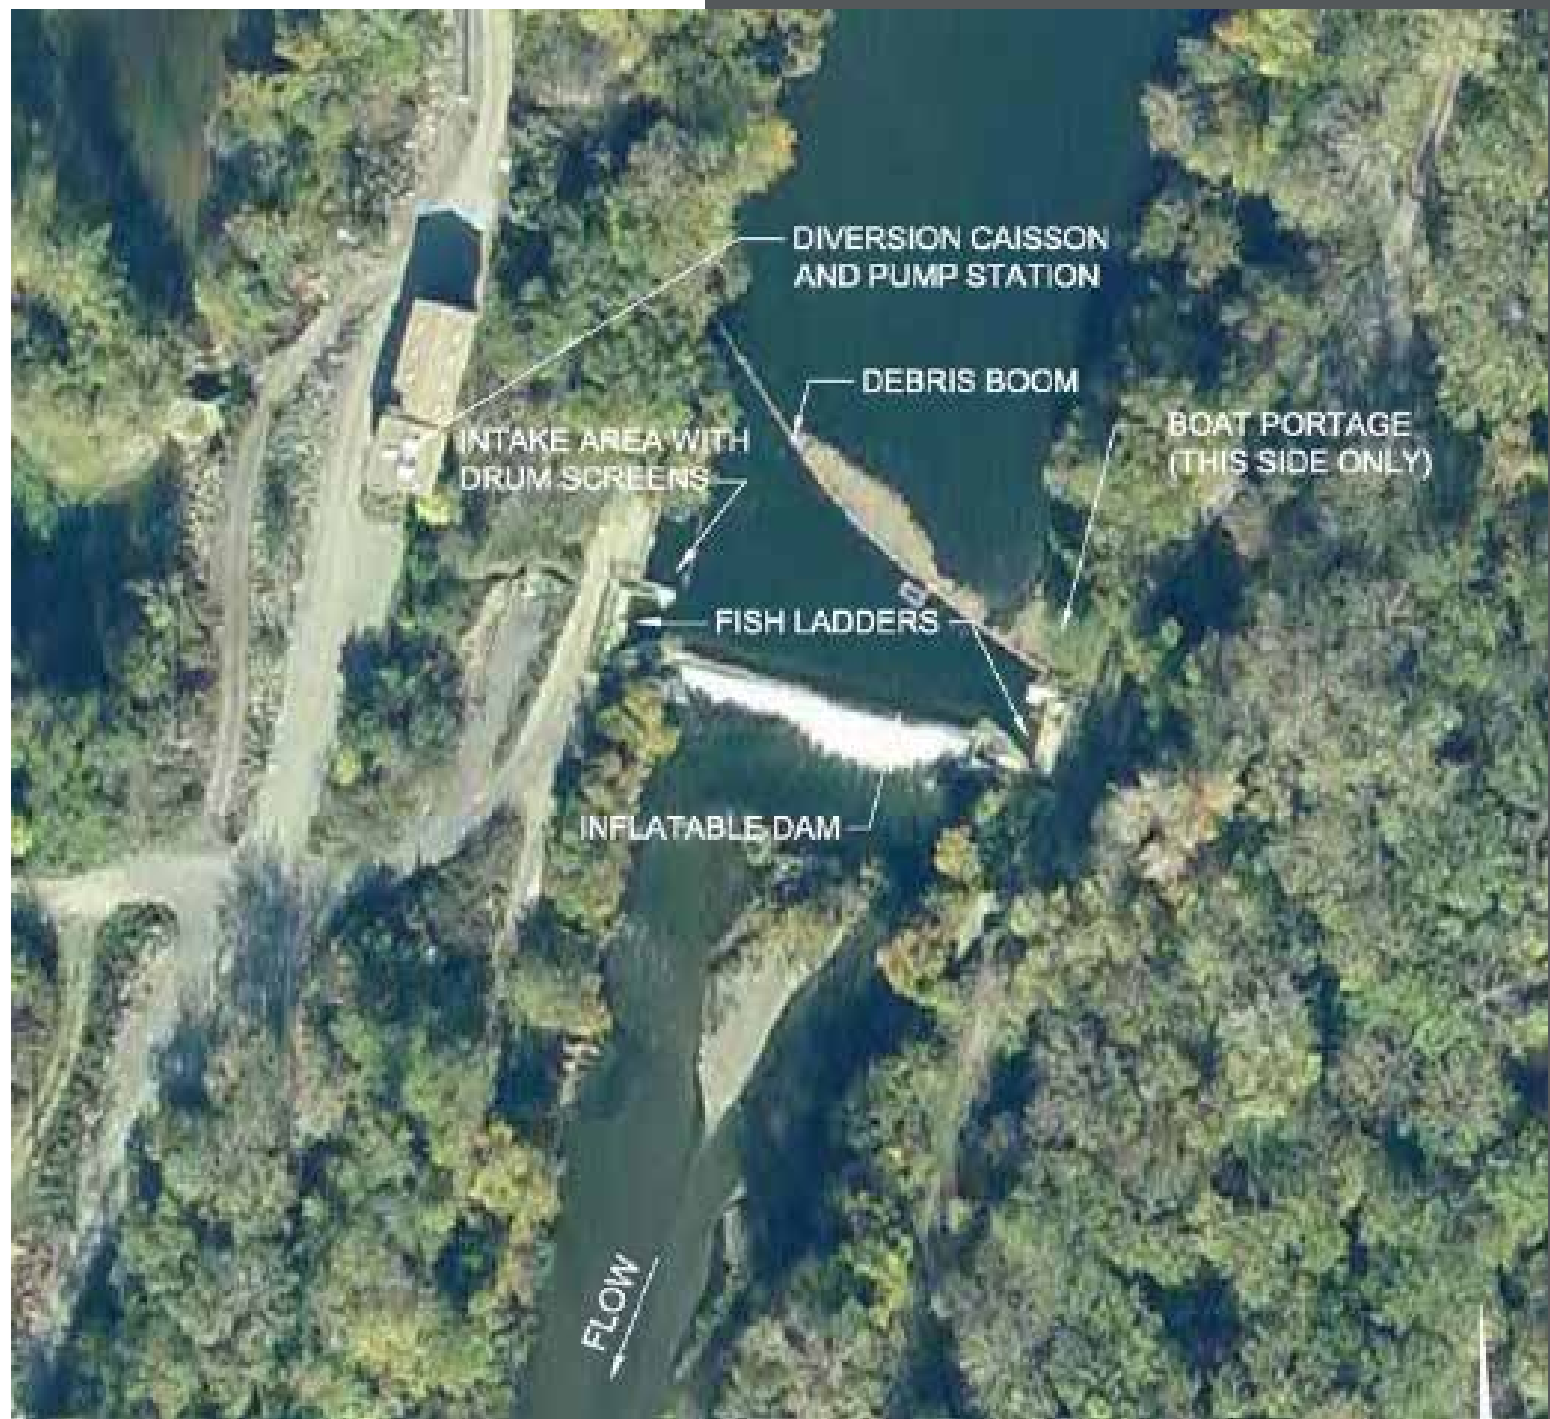
DIVERSION CAISSON
AND PUMP STATION

DEBRIS BOOM

INTAKE AREA WITH
DRUM SCREENS

BOAT PORTAGE
(THIS SIDE ONLY)

FISH LADDERS

INFLATABLE DAM

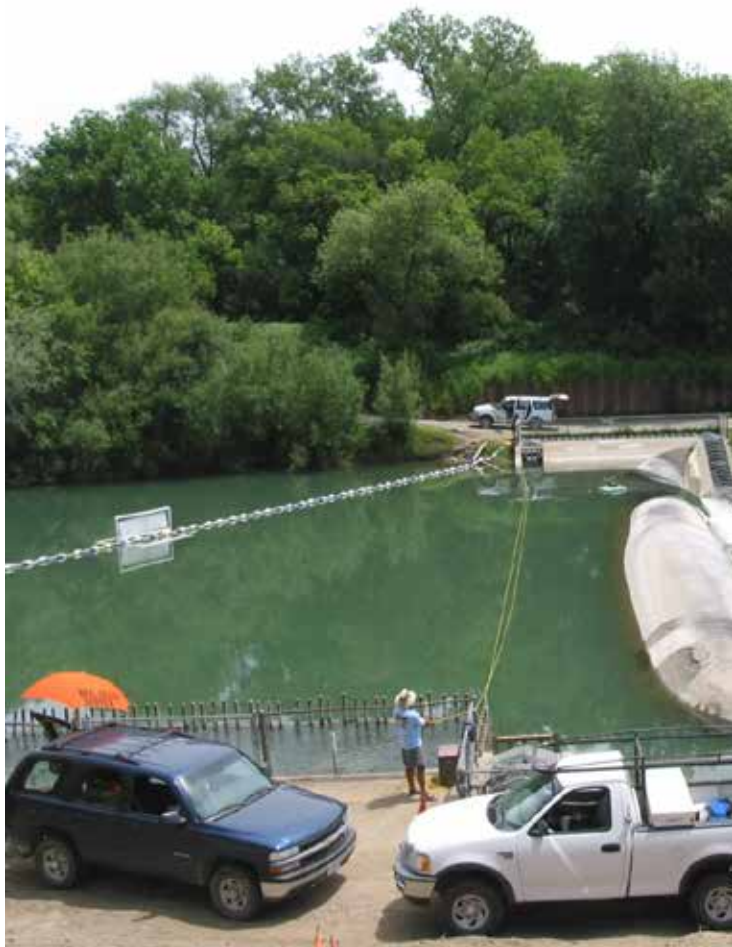
Mainstem, rotary screw traps

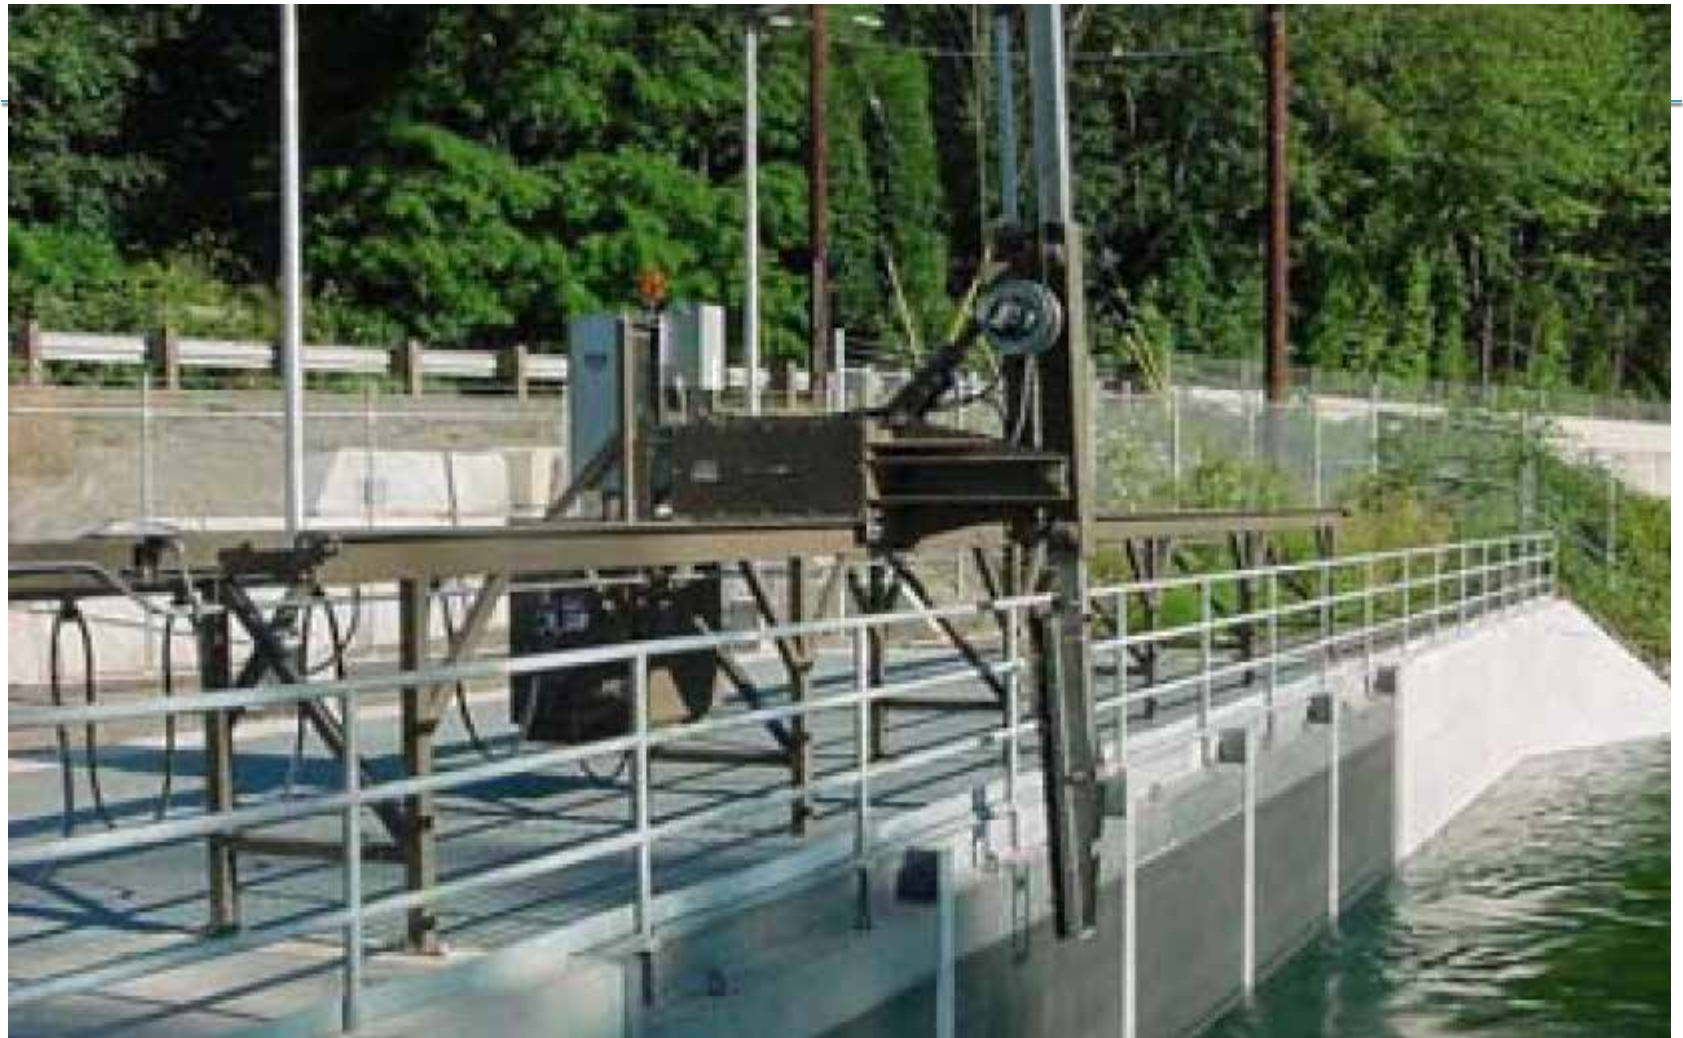
Concept Design

Angled Intake - 300 cfs River Flow, 130 cfs Intake Flow

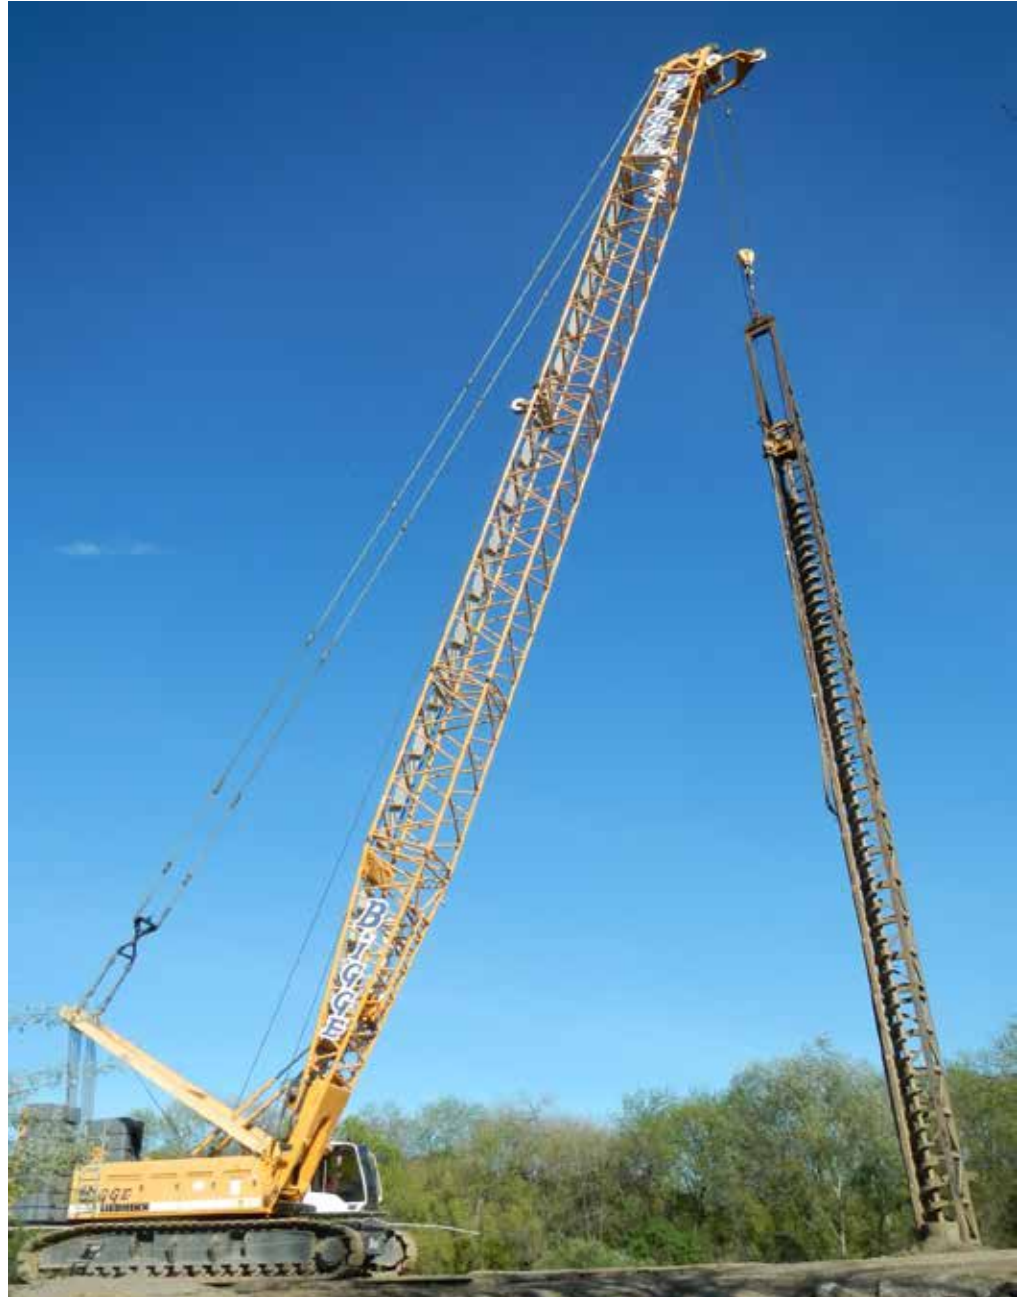
Open throat top boom range diagram
